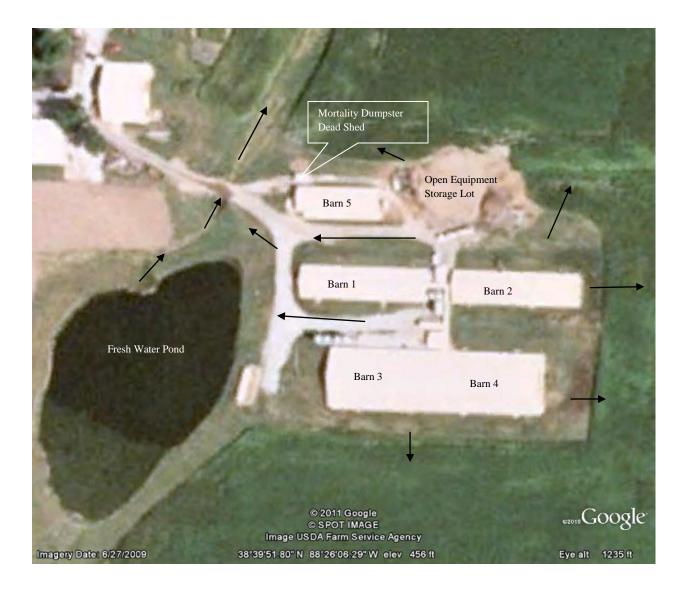
Arrows show the direction of non-contact stormwater drainage. Barns are labeled as shown and the enclosed feed bins are located adjacent to the barns. A fresh water pond is located west of the barns and appears clear. There No discharge was observed at the time of inspection on 05-24-11.
